Appendix 9.4: Sloy Pumped Hydro Storage Scheme: Arboricultural Impact Assessment (AIA)

Sloy Pumped Hydro Storage Scheme Arboricultural Impact Assessment

August 2024

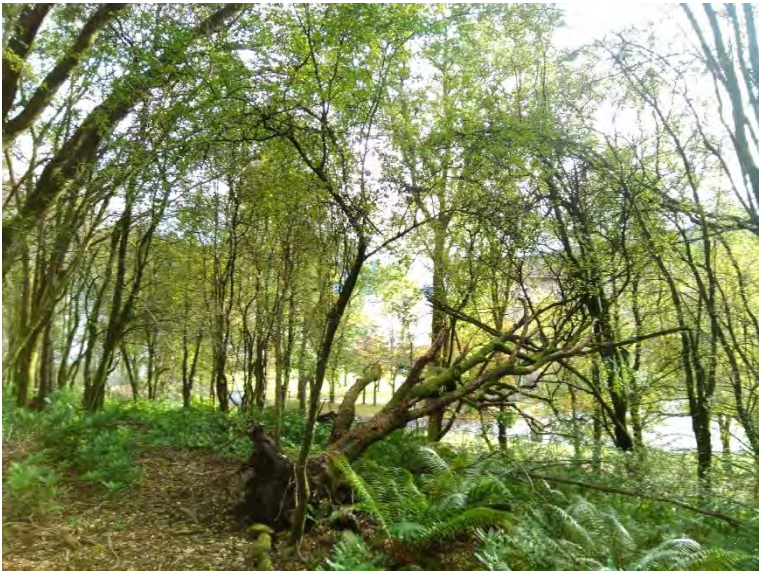
Tree Group ID	Species Composition	Current Maximum DBH (mm)	Current Maximum Height (m)	Age Class (Y/EM/SM/M/LM/A/V)	Group Description	Category U/A/B/C
TG1	Upper Canopy: <ul style="list-style-type: none"> • Ash • Sitka spruce Mid-Canopy: <ul style="list-style-type: none"> • Silver birch • Sycamore • Sitka spruce • Norway maple Understory and Regeneration: <ul style="list-style-type: none"> • Silver birch • Norway maple • Rhododendron 	630	24	Y-M	<p>TG1 is a young to mature mixed wet woodland with a variety of trees species and some <i>Rhododendron ponticum</i> present. Due the size and maturity of the woodland it would be difficult to replace.</p>

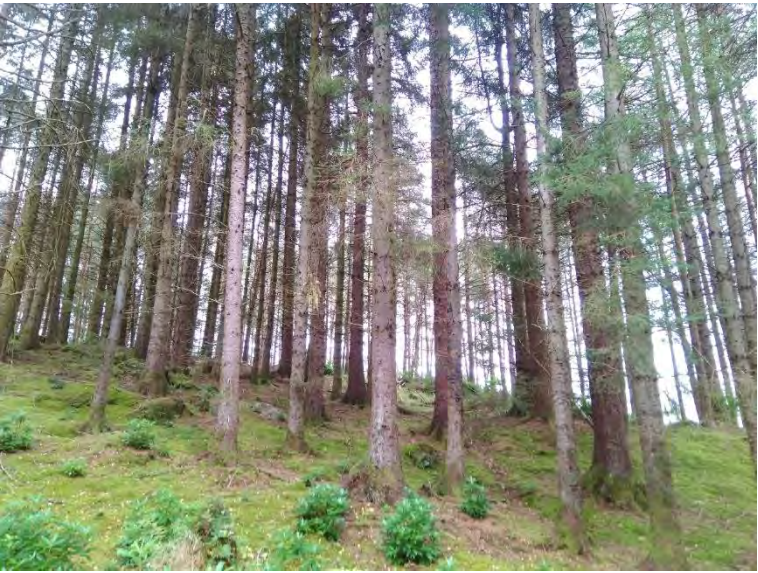
Tree Group ID	Species Composition	Current Maximum DBH (mm)	Current Maximum Height (m)	Age Class (Y/EM/SM/M/LM/A/V)	Group Description	Category U/A/B/C
TG2	Upper Canopy: <ul style="list-style-type: none"> • Larch • Scots pine • Sitka spruce Mid-Canopy: <ul style="list-style-type: none"> • Silver birch • Larch • Scots pine Understory and Regeneration: <ul style="list-style-type: none"> • Holly • Sitka spruce • Rhododendron 	680	22	Y-SM	<p>TG2 is a semi-mature softwood plantation adjacent to the right side of TG1. The woodland is growing on a moderate slope and connects to the road to the east. Due to the size and maturity of the woodland, it would be difficult to replace.</p>

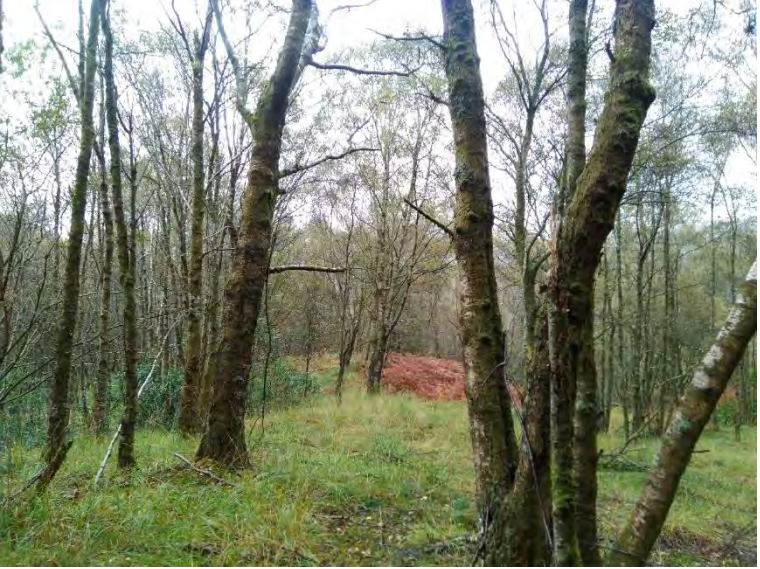
Tree Group ID	Species Composition	Current Maximum DBH (mm)	Current Maximum Height (m)	Age Class (Y/EM/SM/M/LM/A/V)	Group Description	Category U/A/B/C
TG3	Upper Canopy: <ul style="list-style-type: none"> • Silver birch Mid-Canopy: <ul style="list-style-type: none"> • Silver birch • Rowan Understory and Regeneration: <ul style="list-style-type: none"> • Sitka spruce • Holly • Rhododendron 	460	20	Y-SM	<p>TG3 is a semi-mature birch woodland on the north end of the site. The tree group has wet woodland characteristics and continues north past the extent of the survey area. Wet woodlands are a rare and species rich habitat type. Due to the size and maturity of TG3, it would be difficult to replace.</p>

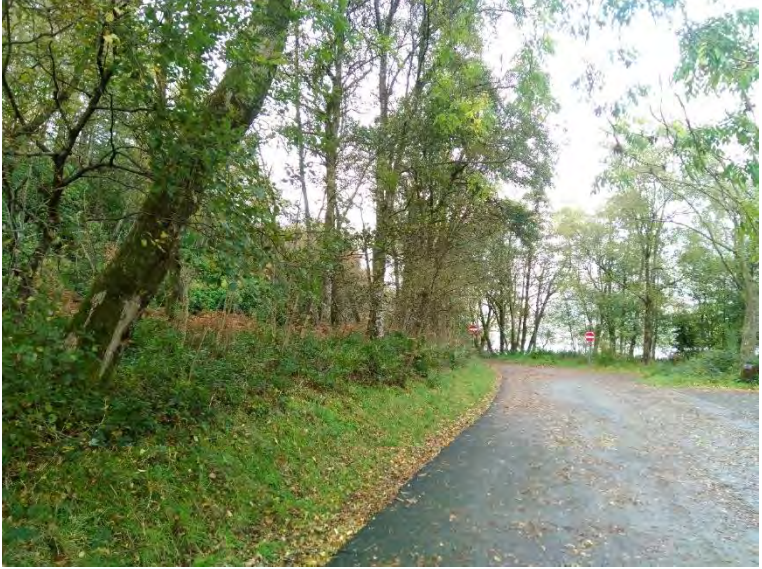
Tree Group ID	Species Composition	Current Maximum DBH (mm)	Current Maximum Height (m)	Age Class (Y/EM/SM/M/LM/A/V)	Group Description	Category U/A/B/C
TG4	Upper Canopy: <ul style="list-style-type: none"> • Ash • Silver birch Mid-Canopy: <ul style="list-style-type: none"> • Common alder • Silver birch • Ash Understory and Regeneration: <ul style="list-style-type: none"> • Alder • Ash • Silver birch 	550	22	Y-SM	<p>TG4 is a small woodland between the Iveruglas Visitor Centre carpark and the A82. The woodland is dominated by ash (which appear symptomatic of ash dieback) and silver birch trees. Due to the size of the trees in the woodland, it would be moderately difficult to replace.</p>
