Sloy Pumped Hydro Storage Scheme Aquatic Macrophyte Outline Invasive Non-Native Species Management Plan

July 2024

Client: ASH Design + Assessment
 Project Title: Sloy Pumped Hydro Storage Scheme
 Report Title: Aquatic Macrophyte Outline Invasive Non-Native Species Management Plan
 Document number: 14389
 Project number: 176783

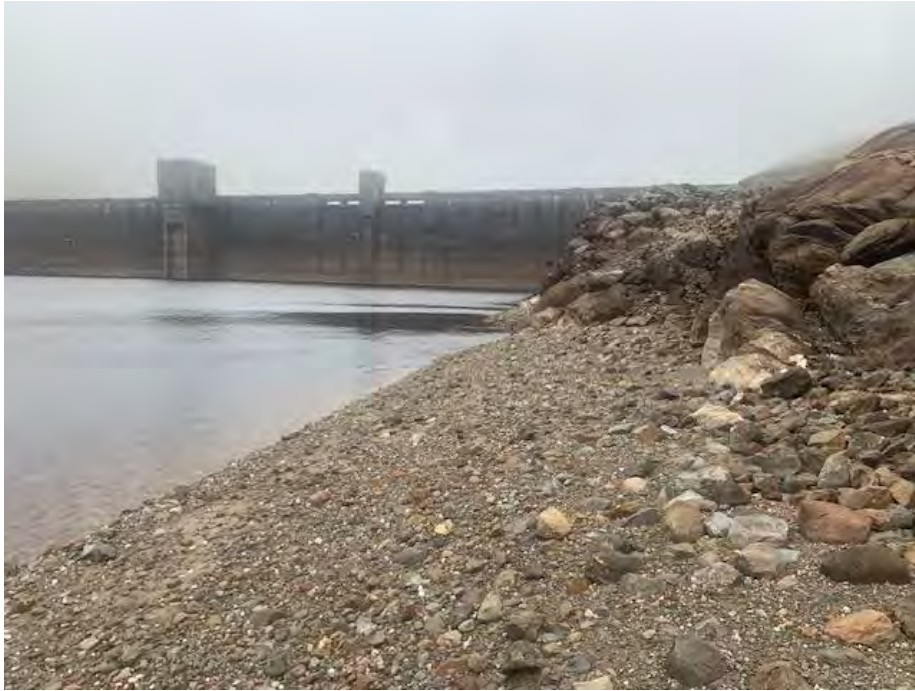
Plate 1: Right bank of Loch Sloy area

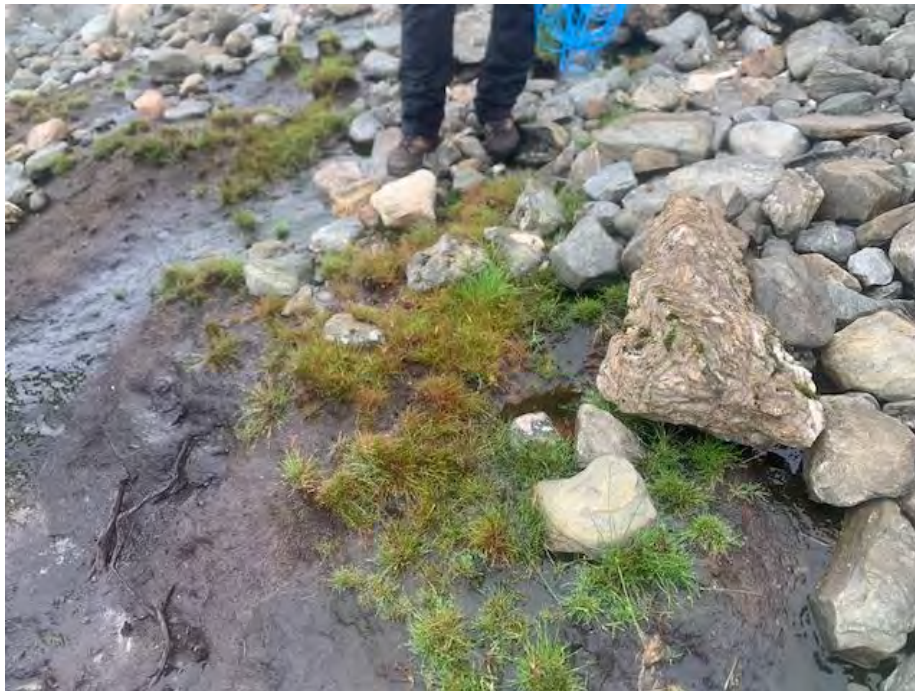
These species were restricted to small sections of remnant peat cover. Vegetation cover was less than 5% and absent from the lower drawdown area, as seen in Plates 4, 5, 6, and 7 in Appendix B.

Plate 2: Small patches of vegetation on the right bank of Loch Sloy

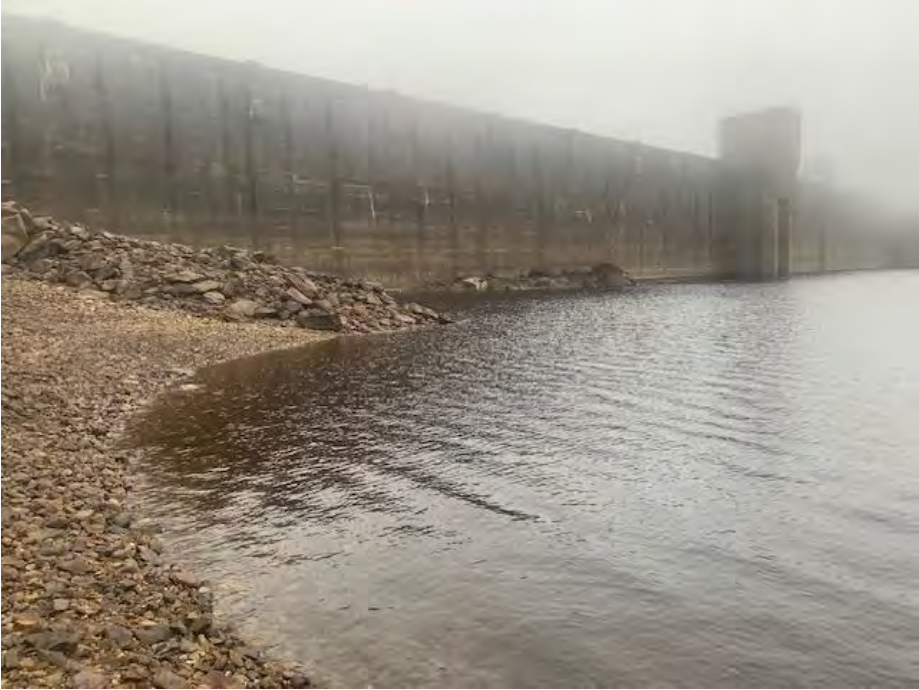
Plate 3: Left bank of Loch Sloy survey area

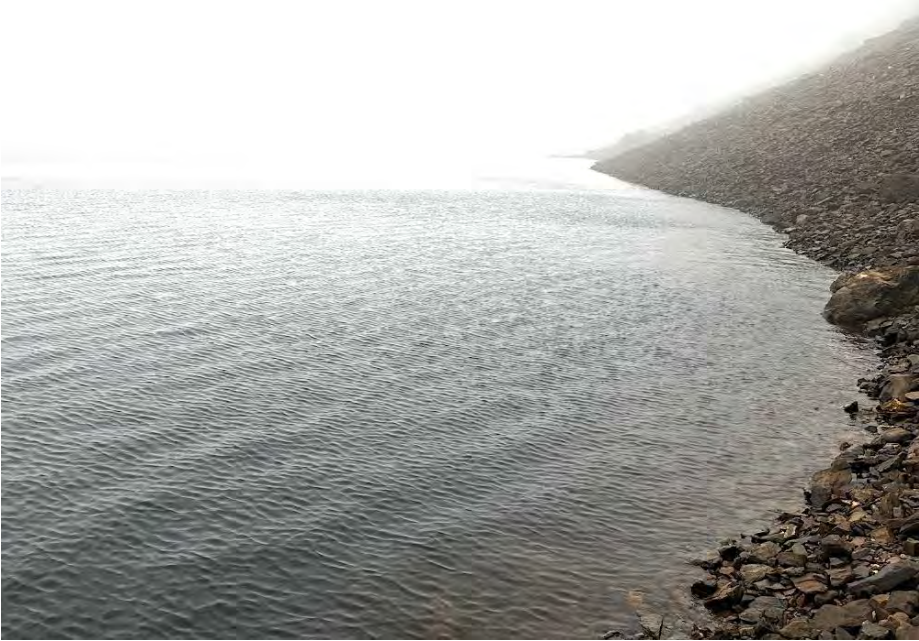
Plate 4 in Appendix B shows the reservoir's level during the time of the survey, which is significantly drawn down.

Plate 4: Left bank slope at Loch Sloy

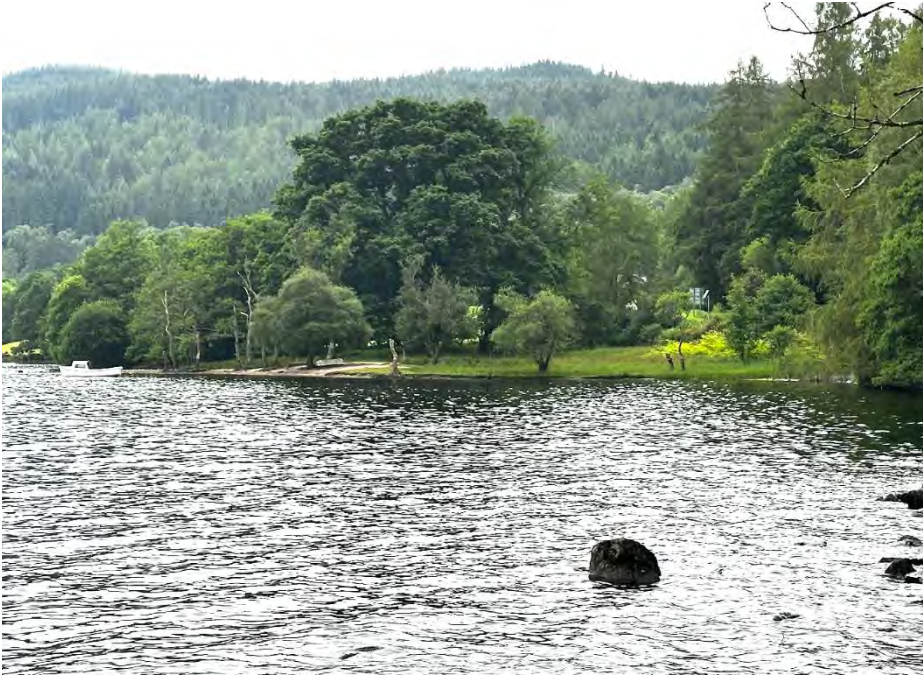
The south bank on the mouth of the bay had a substrate more suited to macrophytes consisting of sand, grit, gravel and pebbles. In contrast, the north bank consisted of engineered rock armour boulders (RipRap) to avoid erosion of the banks protecting the Inveruglas visitor centre. Closer to the mouth of the dam intake, the substrate was more akin to the south bank.

Figure Plate: Right bank of Inveruglas Bay survey area

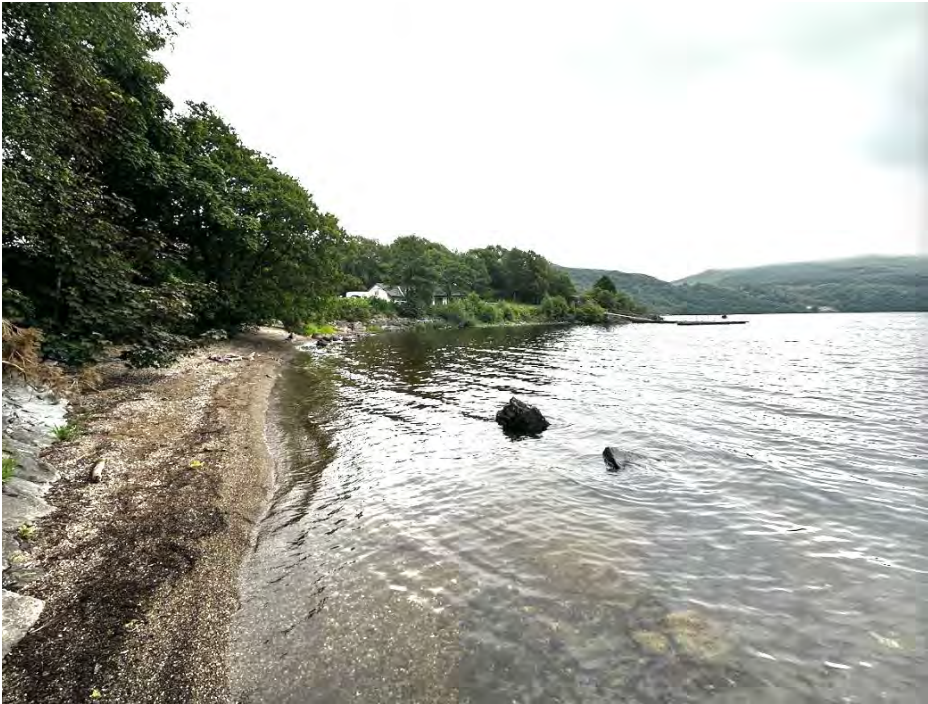
Plate 5: Left bank of Inveruglas Bay survey area
