Technical Appendix 8.4: Schedule of Watercourse Crossings

Glentarken Wind Farm

SSE Renewables

SLR Project No.: 405.065137.00001

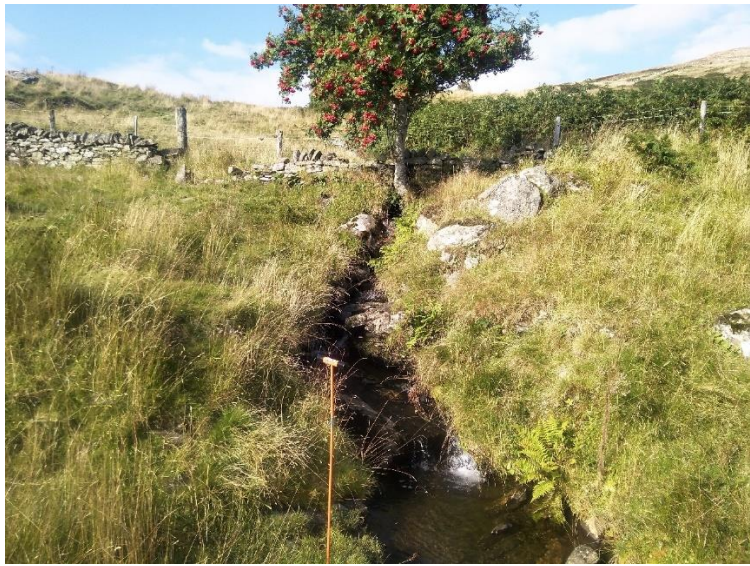
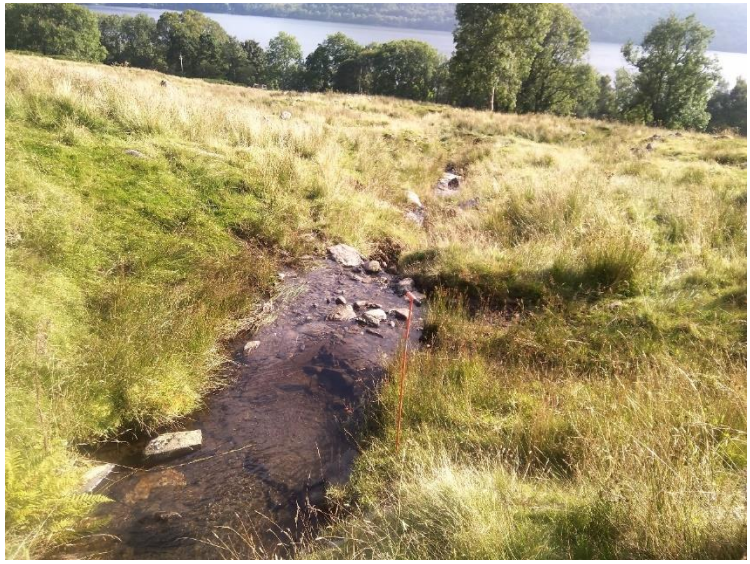
Watercourse Crossing ID	WX01
Watercourse Crossing Details	<p>Grid Reference: E 262053 / N 724588</p> <p>Status: New</p> <p>Watercourse Width: 1.5 m</p> <p>Watercourse Depth: 0.3 m</p> <p>Notes: None.</p>
Photograph Looking Upstream

Photograph Looking Downstream

Potential Crossing Type Likely Required CAR Authorisation	Culvert Registration

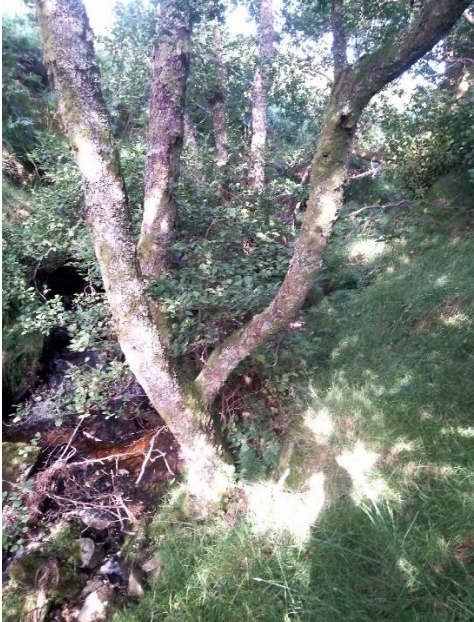
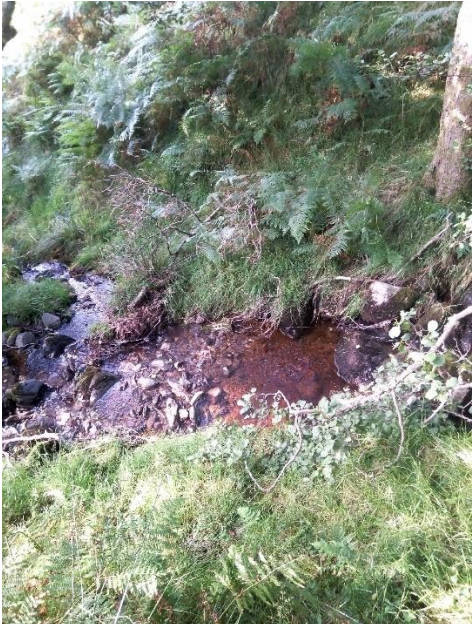
Watercourse Crossing ID	WX04
Watercourse Crossing Details	<p>Grid Reference: E 262068 / N 725602</p> <p>Status: New</p> <p>Watercourse Width: 1.5 m</p> <p>Watercourse Depth: 0.2 m</p> <p>Notes: Watercourse heavily vegetated at crossing point so watercourse has been surveyed approximately 50 m upstream of proposed crossing point.</p>
Photograph Looking Upstream

Photograph Looking Downstream

Potential Crossing Type Likely Required CAR Authorisation	Culvert Registration

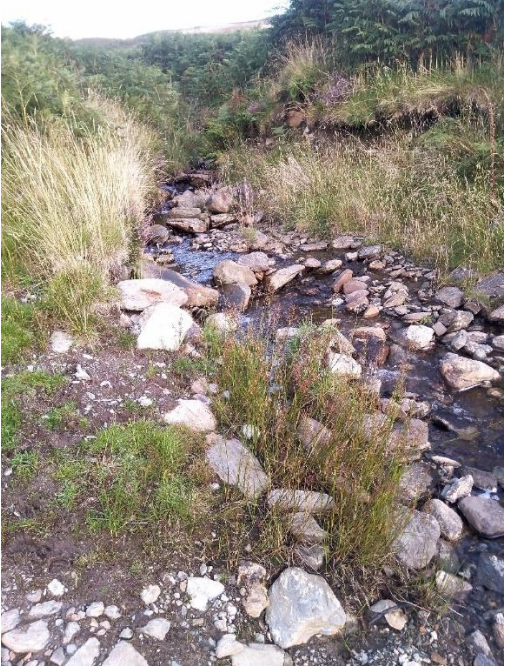
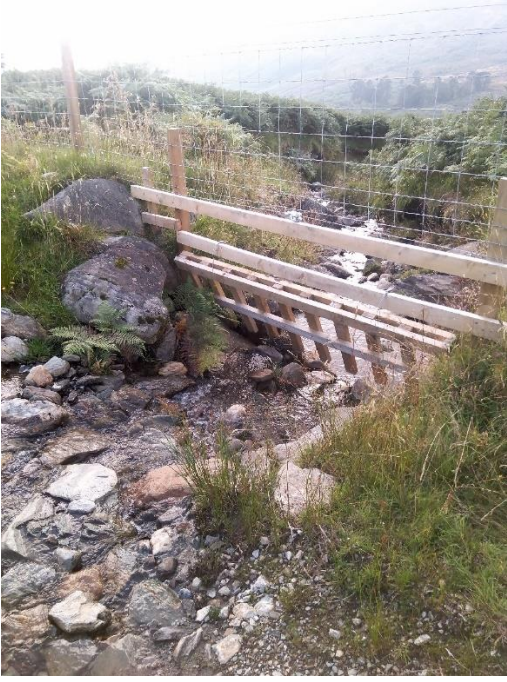
Watercourse Crossing ID	WX05
Watercourse Crossing Details	<p>Grid Reference: E 262206 / N 725603</p> <p>Status: Existing to be upgraded</p> <p>Watercourse Width: 1.5 m</p> <p>Watercourse Depth: 0.2 m</p> <p>Notes: Existing ford crossing.</p>
Photograph Looking Upstream

<p>A photograph showing a rocky watercourse crossing. The water is shallow and flows over a bed of large and small rocks. The banks are covered with tall grasses and some shrubs. The background shows a hilly landscape with more vegetation.</p>
Photograph Looking Downstream

<p>A photograph showing a rocky watercourse crossing from a downstream perspective. A wooden fence with wire mesh is visible on the right side, partially enclosing the crossing. The water flows over a rocky bed. The background shows a valley with hills and vegetation.</p>
Potential Crossing Type Likely Required CAR Authorisation	Culvert Registration

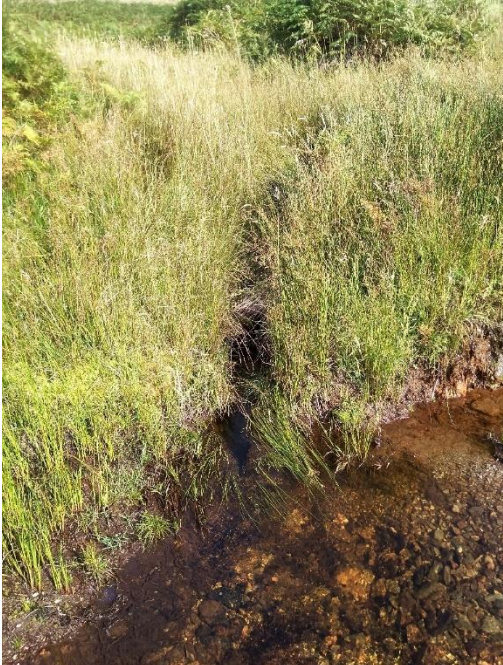
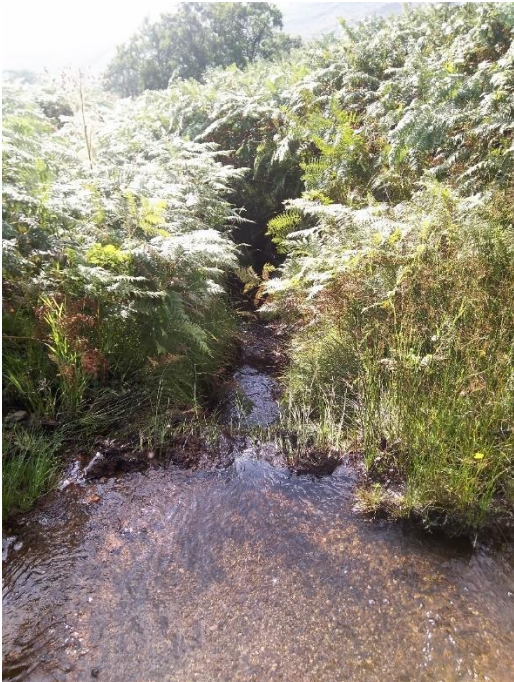
Watercourse Crossing ID	WX06
Watercourse Crossing Details	<p>Grid Reference: E 262531 / N 726342</p> <p>Status: New</p> <p>Watercourse Width: 0.7 m</p> <p>Watercourse Depth: 0.2 m</p> <p>Notes: Water ponds at proposed crossing point. The channel is narrower both upstream and downstream of the proposed crossing point.</p>
Photograph Looking Upstream

Photograph Looking Downstream

Potential Crossing Type Likely Required CAR Authorisation	Culvert Registration

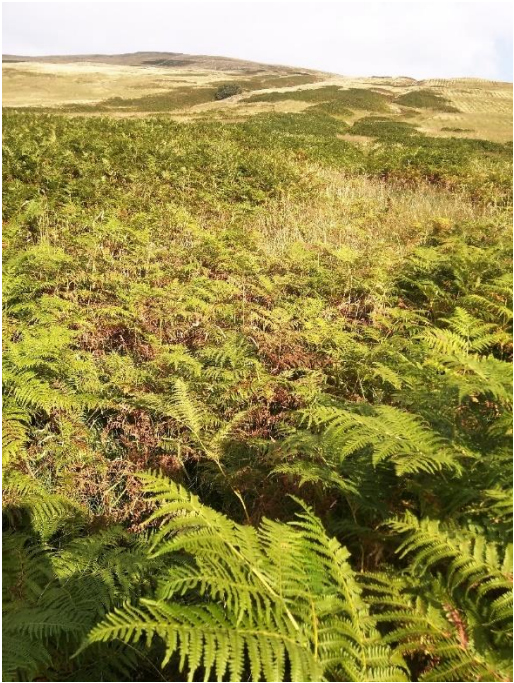
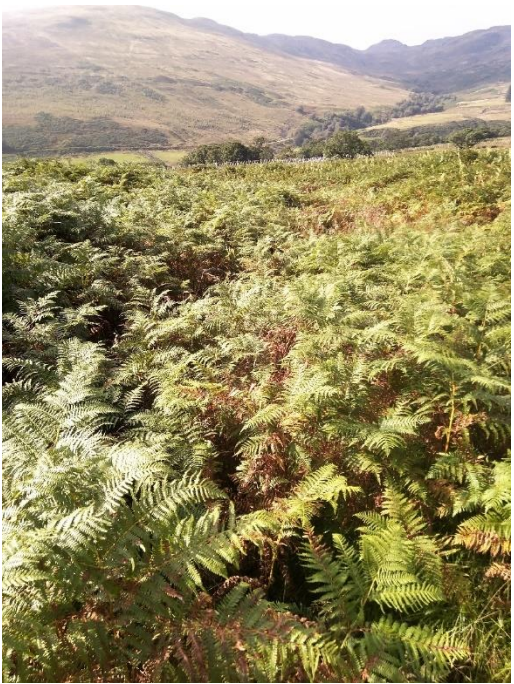
Watercourse Crossing ID	WX07
Watercourse Crossing Details	<p>Grid Reference: E 262552 / N 726383</p> <p>Status: New</p> <p>Watercourse Width: 0.5 m</p> <p>Watercourse Depth: 0.1 m</p> <p>Notes: Watercourse is heavily vegetated.</p>
Photograph Looking Upstream

Photograph Looking Downstream

Potential Crossing Type Likely Required CAR Authorisation	Culvert Registration

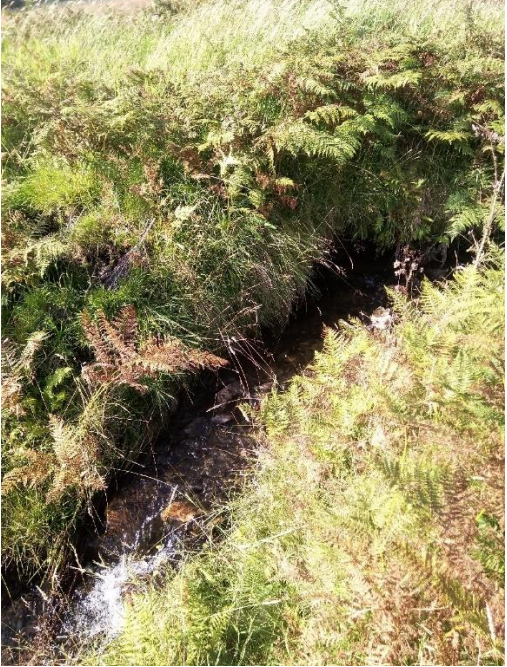
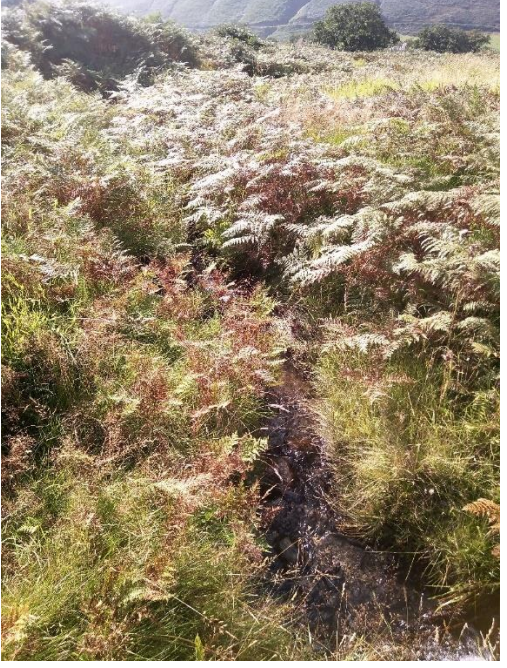
Watercourse Crossing ID	WX08
Watercourse Crossing Details	<p>Grid Reference: E 262574 / N 726458</p> <p>Status: New</p> <p>Watercourse Width: 0.6 m</p> <p>Watercourse Depth: 0.2 m</p> <p>Notes: None.</p>
Photograph Looking Upstream

Photograph Looking Downstream

Potential Crossing Type Likely Required CAR Authorisation	Culvert Registration

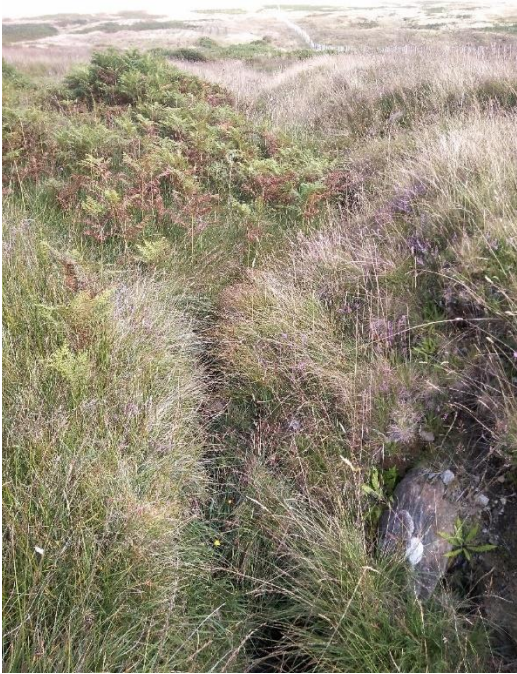
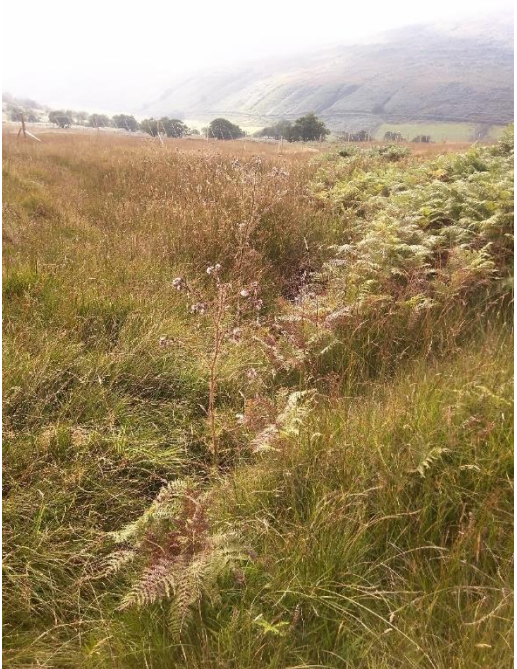
Watercourse Crossing ID	WX09
Watercourse Crossing Details	<p>Grid Reference: E 262660 / N 726760</p> <p>Status: New</p> <p>Watercourse Width: 0.4 m</p> <p>Watercourse Depth: 0.2 m</p> <p>Notes: None.</p>
Photograph Looking Upstream

Photograph Looking Downstream

Potential Crossing Type Likely Required CAR Authorisation	Culvert Registration

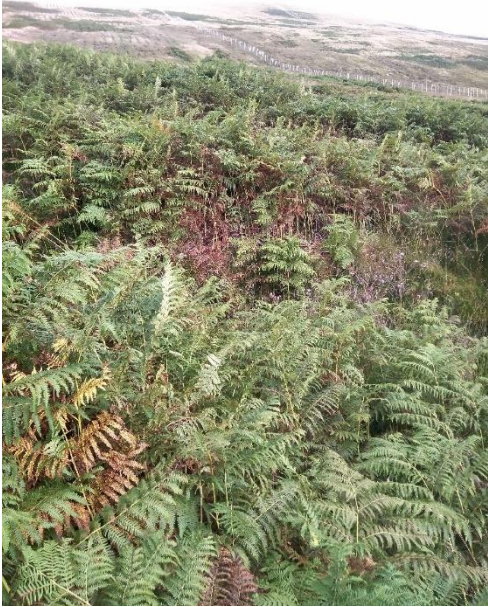
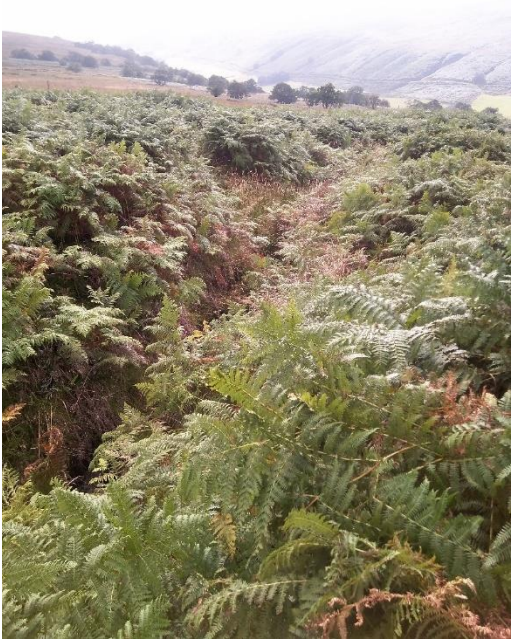
Watercourse Crossing ID	WX10
Watercourse Crossing Details	<p>Grid Reference: E 262675 / N 726794</p> <p>Status: New</p> <p>Watercourse Width: 0.9 m</p> <p>Watercourse Depth: 0.3 m</p> <p>Notes: Heavily vegetated channel.</p>
Photograph Looking Upstream

Photograph Looking Downstream

Potential Crossing Type Likely Required CAR Authorisation	Culvert Registration

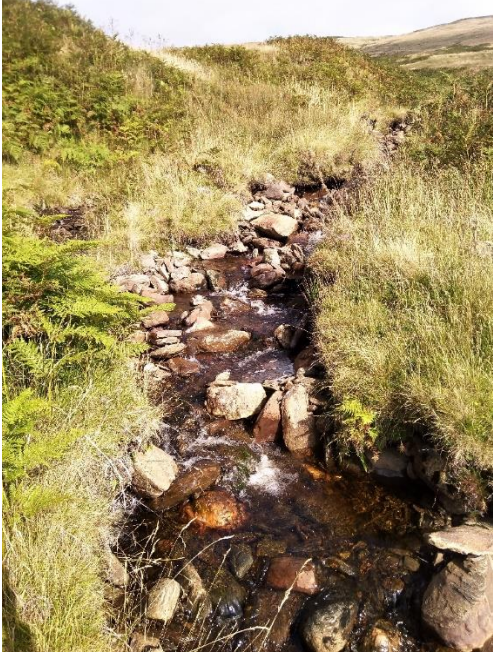
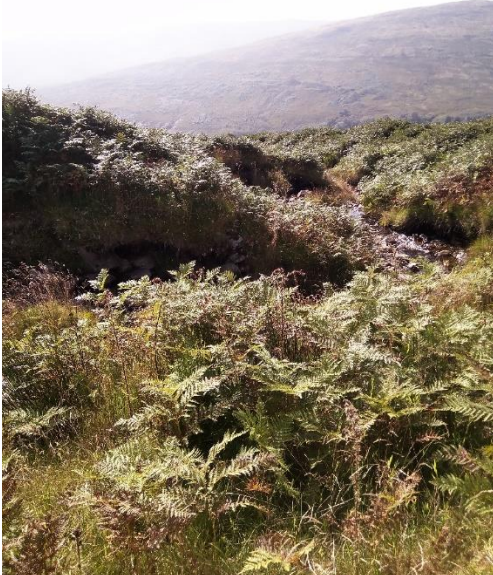
Watercourse Crossing ID	WX12
Watercourse Crossing Details	<p>Grid Reference: E 262797 / N 727168</p> <p>Status: New</p> <p>Watercourse Width: 1.5 m</p> <p>Watercourse Depth: 0.3 m</p> <p>Notes: None.</p>
Photograph Looking Upstream

Photograph Looking Downstream

Potential Crossing Type Likely Required CAR Authorisation	Culvert Registration

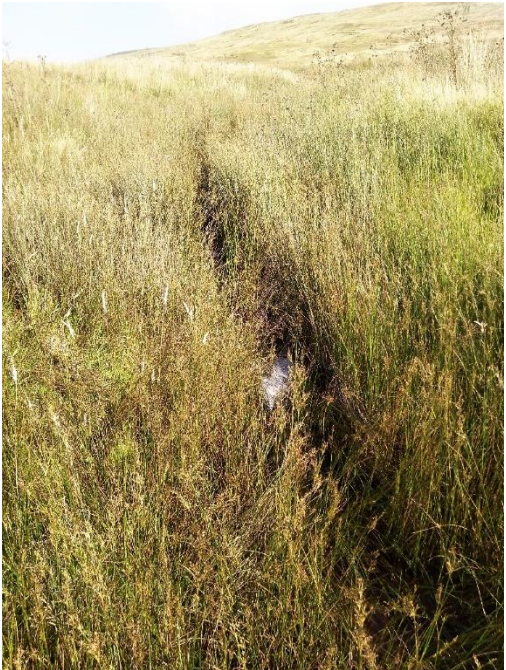
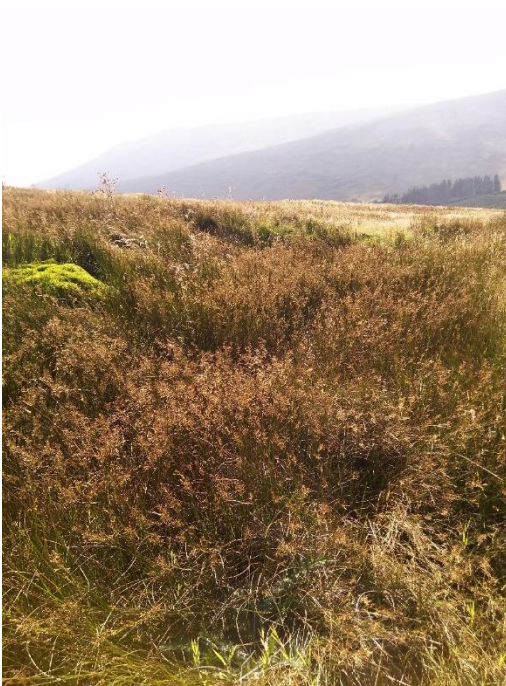
Watercourse Crossing ID	WX13
Watercourse Crossing Details	<p>Grid Reference: E 262913 / N 727613</p> <p>Status: New</p> <p>Watercourse Width: 0.6 m</p> <p>Watercourse Depth: 0.2 m</p> <p>Notes: None.</p>
Photograph Looking Upstream

Photograph Looking Downstream

Potential Crossing Type Likely Required CAR Authorisation	Culvert Registration

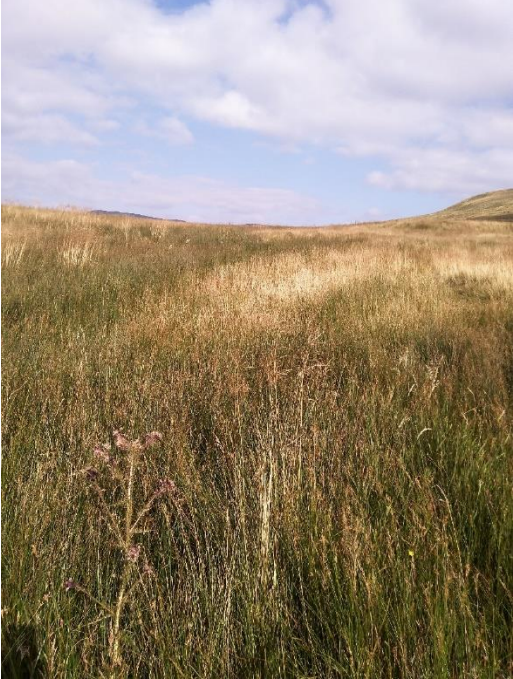
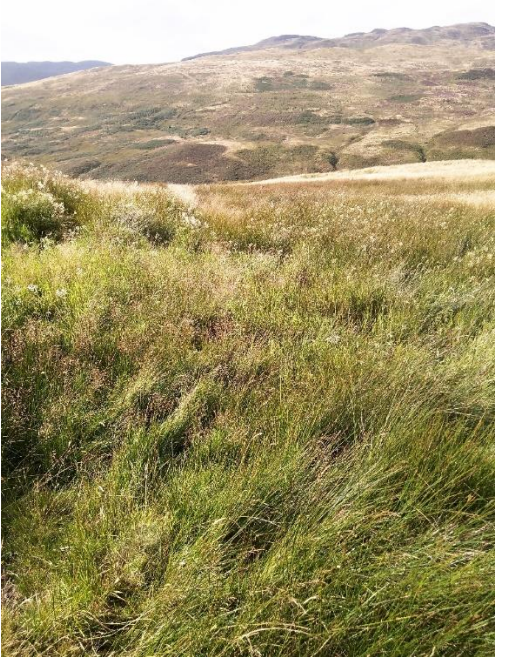
Watercourse Crossing ID	WX14
Watercourse Crossing Details	<p>Grid Reference: E 263032 / N 727908</p> <p>Status: New</p> <p>Watercourse Width: N/A</p> <p>Watercourse Depth: N/A</p> <p>Notes: No defined watercourse observed. Wider channel extends to approximately 5 m wide.</p>
Photograph Looking Upstream

Photograph Looking Downstream

Potential Crossing Type Likely Required CAR Authorisation	Culvert Registration

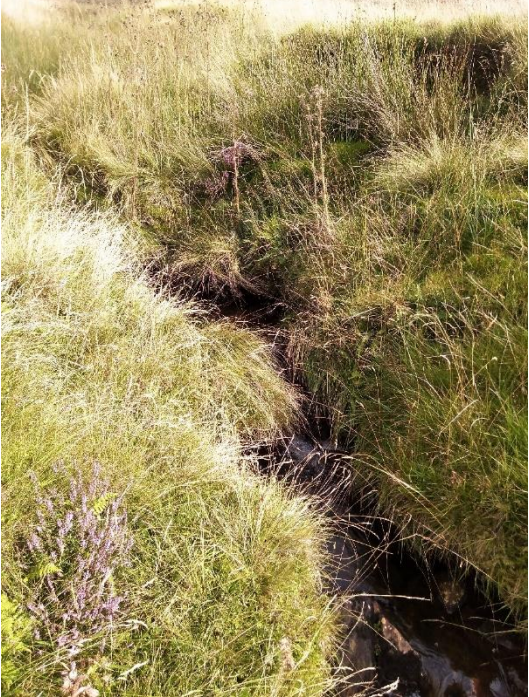
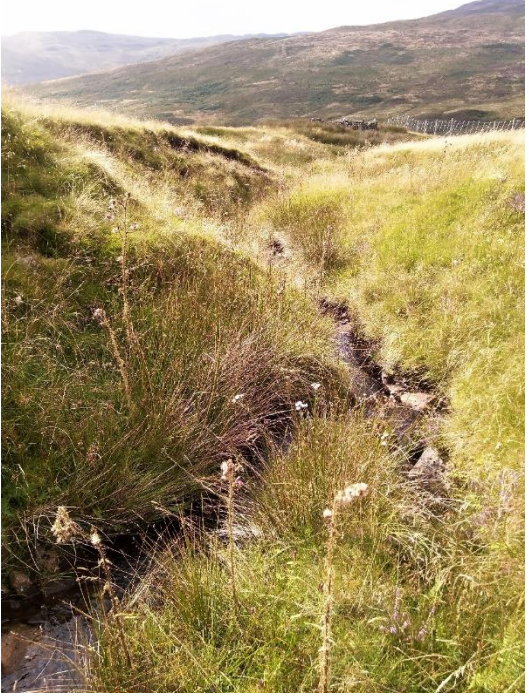
Watercourse Crossing ID	WX15
Watercourse Crossing Details	<p>Grid Reference: E 263133 / N 728085</p> <p>Status: New</p> <p>Watercourse Width: 0.8 m</p> <p>Watercourse Depth: 0.1 m</p> <p>Notes: None.</p>
Photograph Looking Upstream

Photograph Looking Downstream

Potential Crossing Type Likely Required CAR Authorisation	Culvert Registration

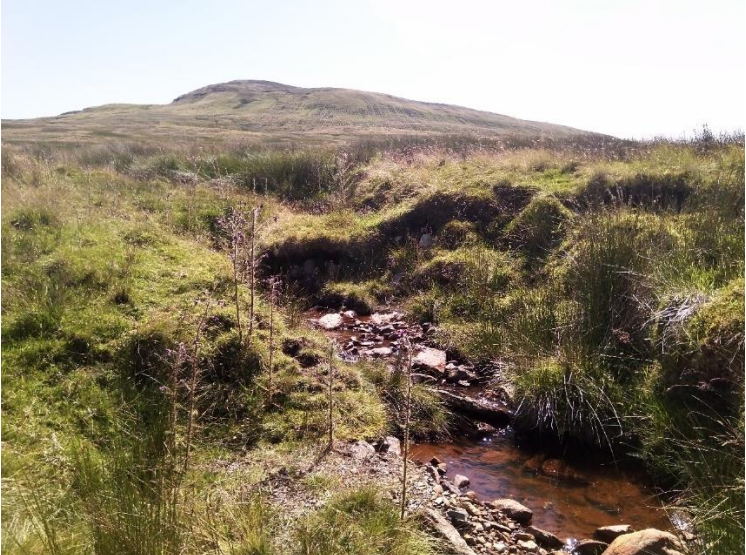
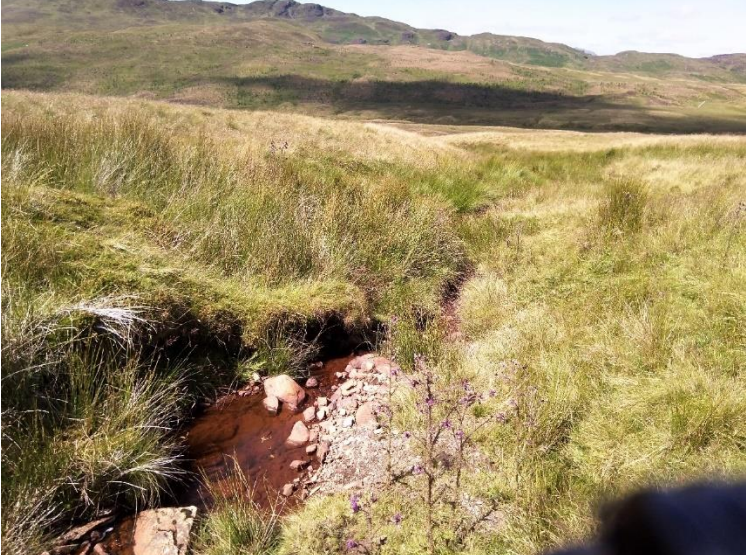
Watercourse Crossing ID	WX16
Watercourse Crossing Details	<p>Grid Reference: E 263662 / N 728540</p> <p>Status: New</p> <p>Watercourse Width: 0.8 m</p> <p>Watercourse Depth: 0.3 m</p> <p>Notes: Watercourse is located within an incised gully which is approximately 15 m wide and 8 m deep. Gully becomes less incised approximately 20 m downstream of crossing point.</p>
Photograph Looking Upstream

<p>A photograph showing a small, rocky watercourse flowing through a grassy gully. The water is brownish and the surrounding vegetation is green and yellowish. In the background, there are rolling hills under a clear sky.</p>
Photograph Looking Downstream

<p>A photograph showing a small, rocky watercourse flowing through a grassy field. The water is brownish and the surrounding vegetation is green and yellowish. In the background, there are rolling hills under a clear sky.</p>
Potential Crossing Type Likely Required CAR Authorisation	Culvert Registration

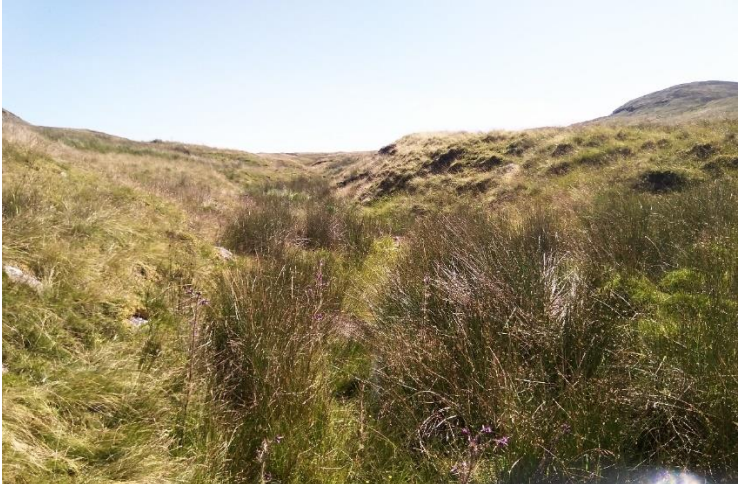
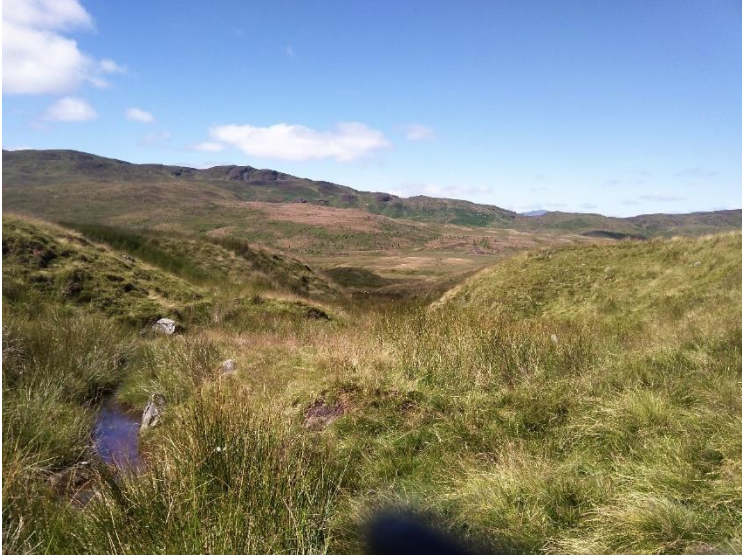
Watercourse Crossing ID	WX17
Watercourse Crossing Details	<p>Grid Reference: E 263779 / N 728626</p> <p>Status: New</p> <p>Watercourse Width: 0.4 m</p> <p>Watercourse Depth: 0.1 m</p> <p>Notes: Watercourse is located within channel which is approximately 10 m deep. SSE hydro asset located approximately 85 m upstream of crossing point.</p>
Photograph Looking Upstream

Photograph Looking Downstream

Potential Crossing Type Likely Required CAR Authorisation	Culvert Registration

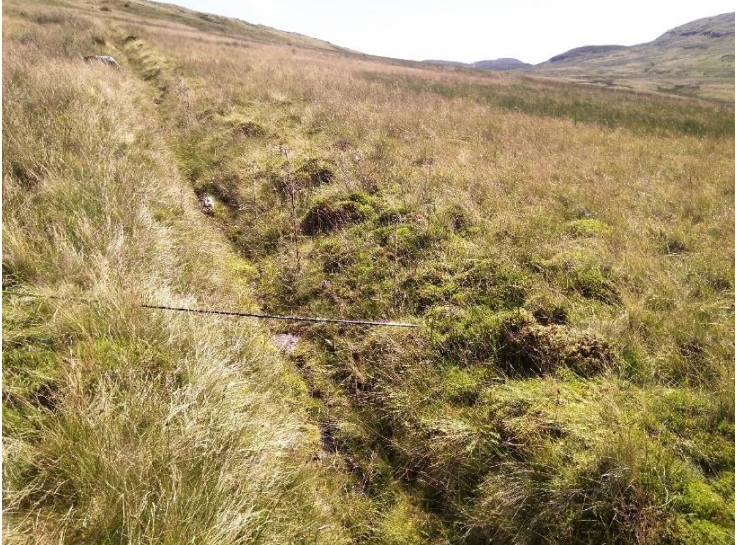
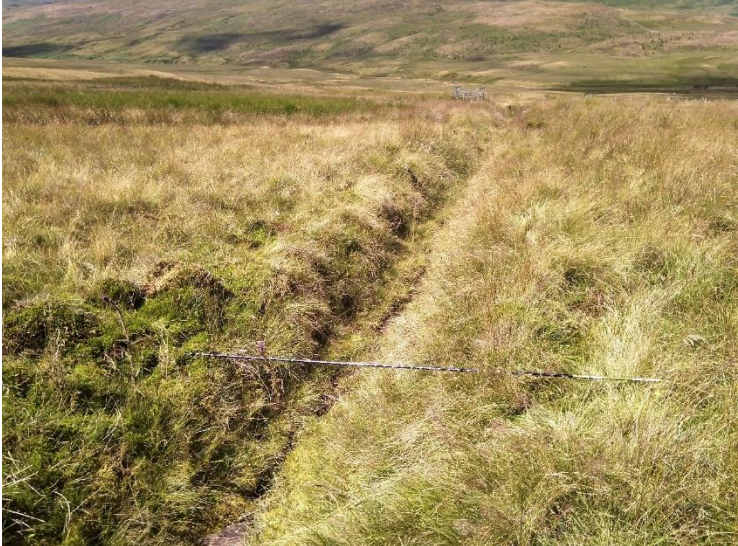
Watercourse Crossing ID	WX18
Watercourse Crossing Details	<p>Grid Reference: E 263969 / N 728772</p> <p>Status: New</p> <p>Watercourse Width: 1.7 m</p> <p>Watercourse Depth: 0.7 m</p> <p>Notes: Linear drainage ditch.</p>
Photograph Looking Upstream

Photograph Looking Downstream

Potential Crossing Type Likely Required CAR Authorisation	Culvert Registration

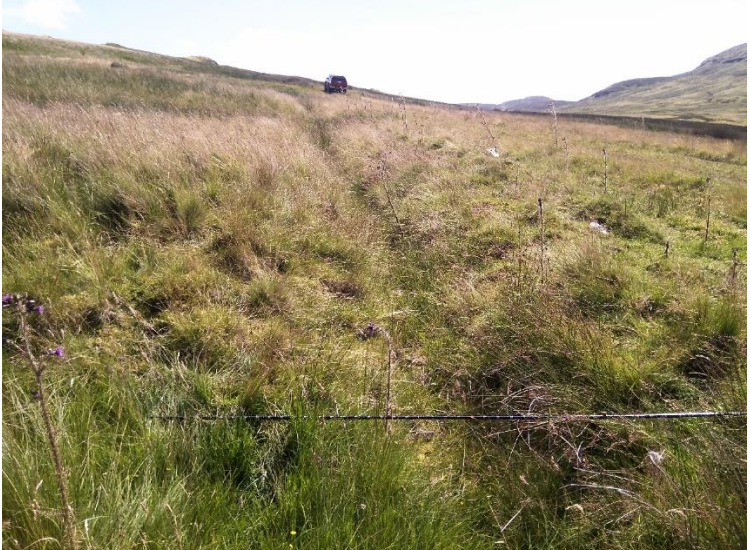
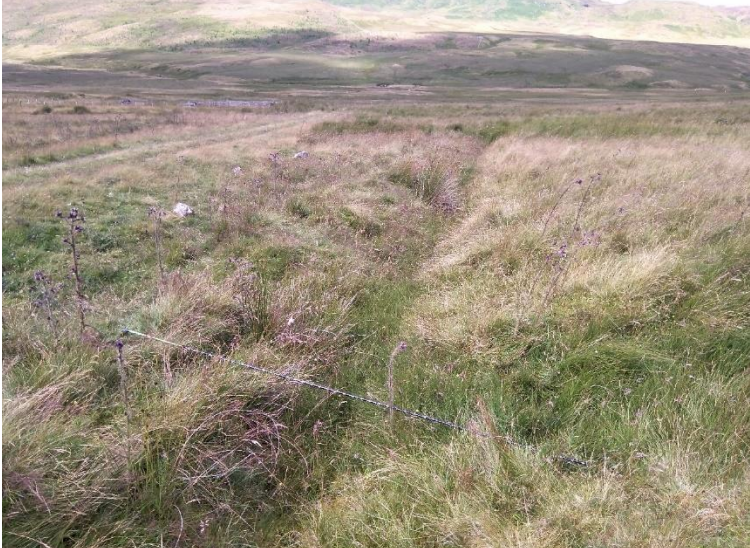
Watercourse Crossing ID	WX19
Watercourse Crossing Details	<p>Grid Reference: E 264008 / N 728807</p> <p>Status: New</p> <p>Watercourse Width: N/A</p> <p>Watercourse Depth: N/A</p> <p>Notes: Channel noted to be 1.3 m wide and 0.7 m deep. No flowing water observed during the survey. Linear drainage ditch.</p>
Photograph Looking Upstream

Photograph Looking Downstream

Potential Crossing Type Likely Required CAR Authorisation	Culvert Registration

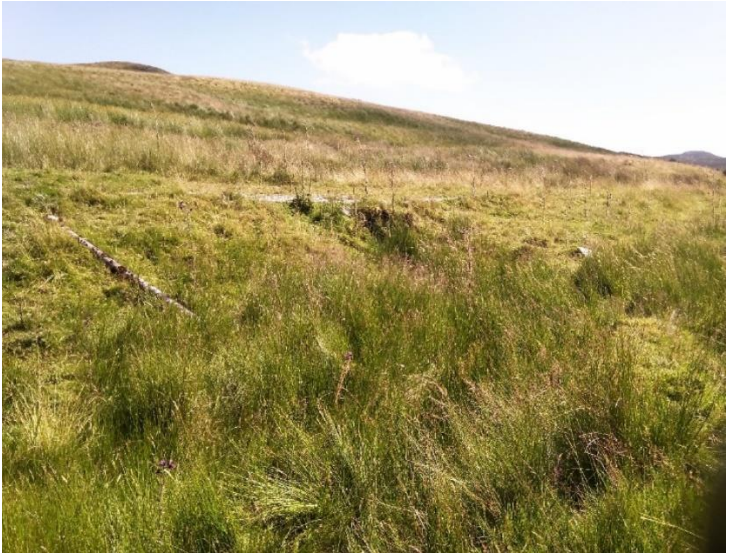
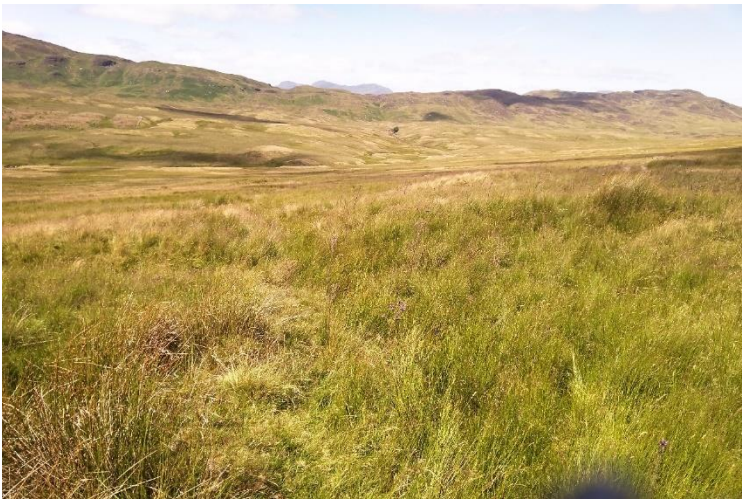
Watercourse Crossing ID	WX20
Watercourse Crossing Details	Grid Reference: E 264041 / N 728820

Watercourse Crossing ID	WX20
	<p>Status: New</p> <p>Watercourse Width: N/A</p> <p>Watercourse Depth: N/A</p> <p>Notes: Channel extends to approximately 0.8 m wide and 0.4 m deep however no flowing water was recorded during the survey. 300 mm circular culvert is noted underneath an existing track approximately 5 m upstream of proposed crossing location.</p>
Photograph Looking Upstream

Photograph Looking Downstream

Potential Crossing Type Likely Required CAR Authorisation	Culvert Registration

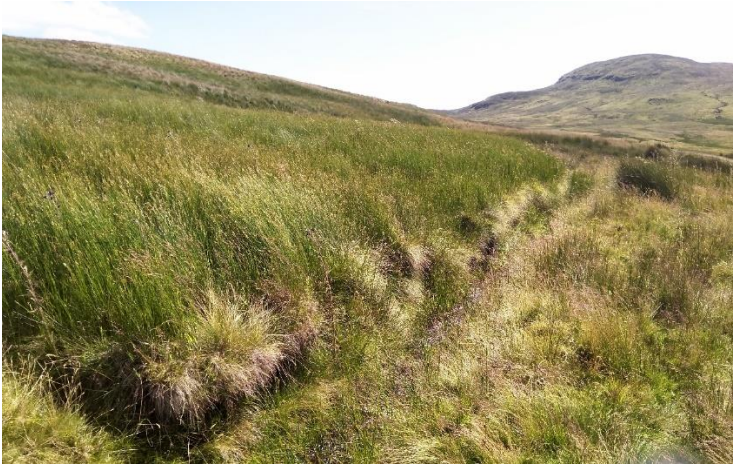
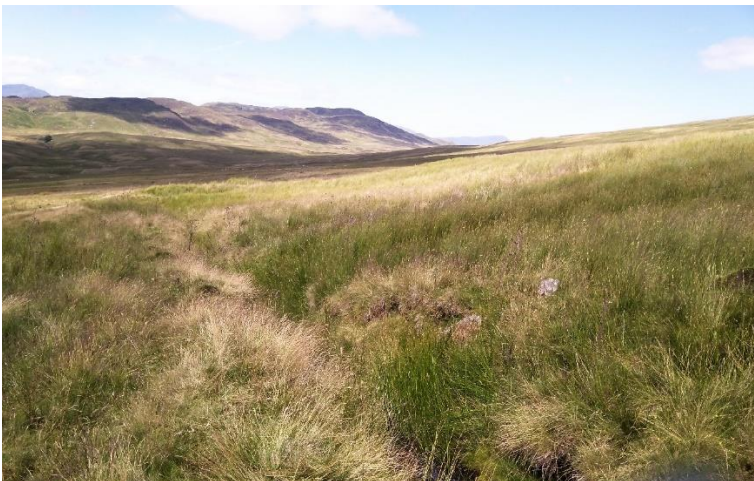
Watercourse Crossing ID	WX21
Watercourse Crossing Details	<p>Grid Reference: E 264059 / N 728838</p> <p>Status: New</p>

Watercourse Crossing ID	WX21
	<p>Watercourse Width: 0.7 m Watercourse Depth: 0.3 m Notes: Watercourse is located within a wider channel which is approximately 1 m wide and 0.8 m deep.</p>
<p>Photograph Looking Upstream</p>

<p>Photograph Looking Downstream</p>

<p>Potential Crossing Type Likely Required CAR Authorisation</p>	<p>Culvert Registration</p>

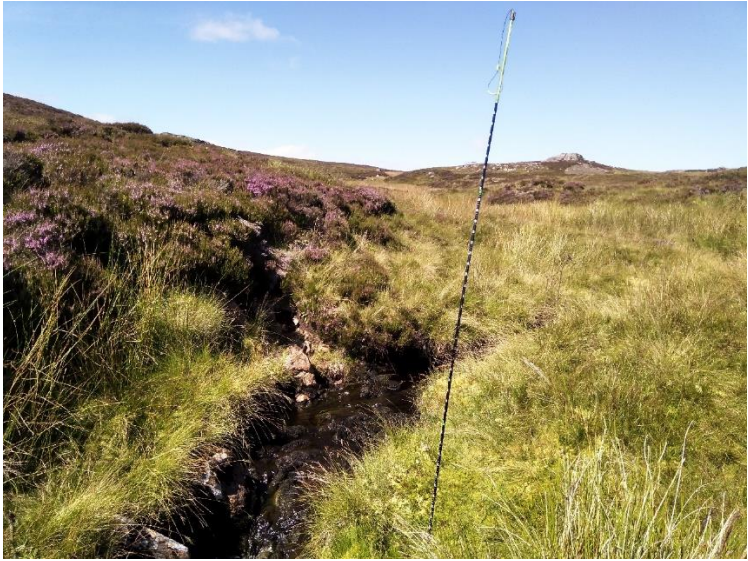
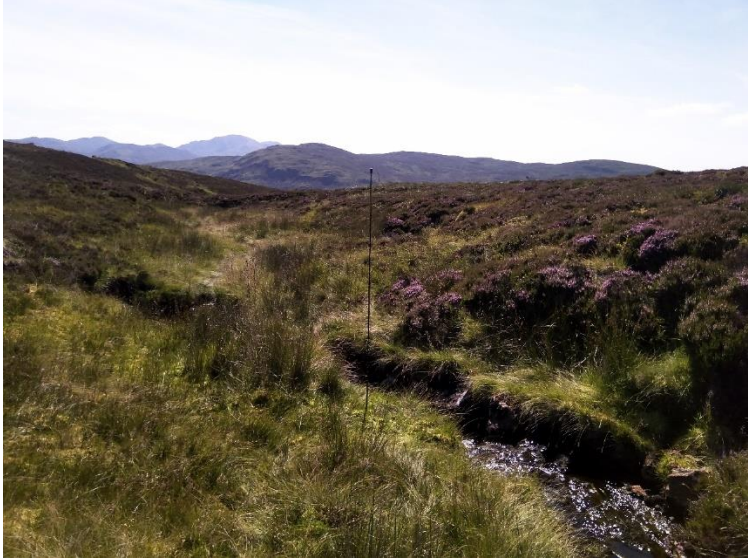
Watercourse Crossing ID	WX22
<p>Watercourse Crossing Details</p>	<p>Grid Reference: E 266557 / N 729034 Status: New</p>

Watercourse Crossing ID	WX22
	<p>Watercourse Width: 1.3 m Watercourse Depth: 0.3 m Notes: Watercourse surveyed approximately 30m downstream of the proposed crossing point. Watercourse located in a wider channel which is approximately 15 m wide and 3 m deep.</p>
<p>Photograph Looking Upstream</p>

<p>Photograph Looking Downstream</p>

<p>Potential Crossing Type Likely Required CAR Authorisation</p>	<p>Culvert Registration</p>

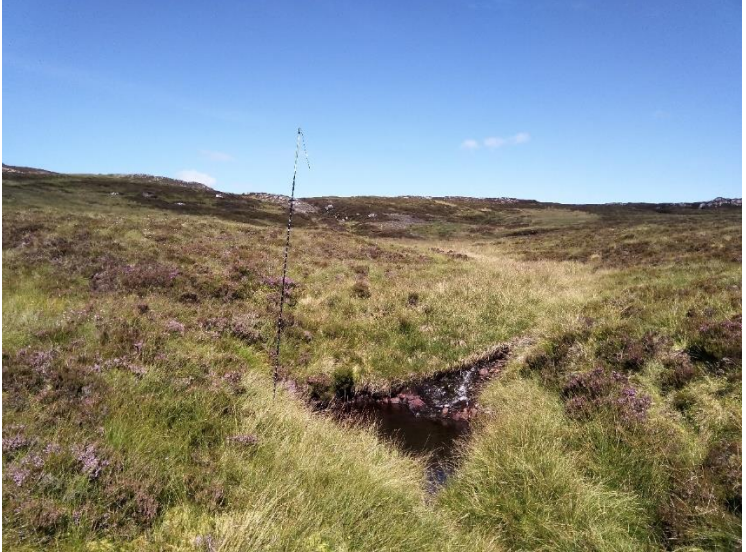
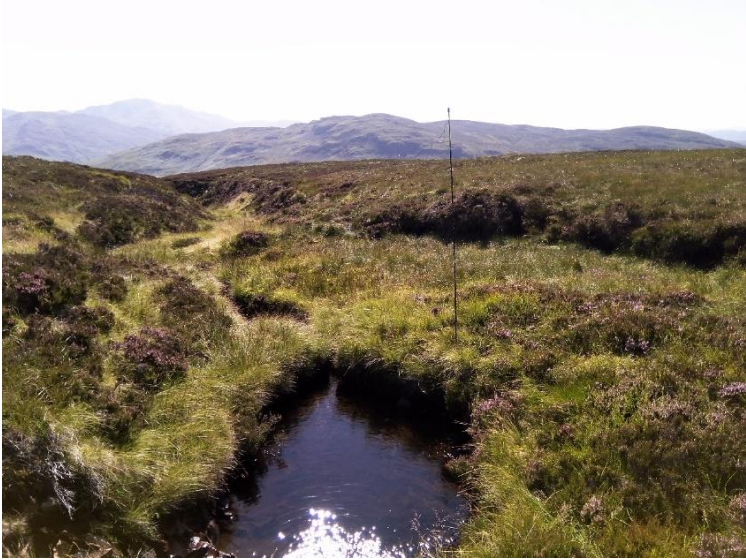
Watercourse Crossing ID	WX23
<p>Watercourse Crossing Details</p>	<p>Grid Reference: E 267340 / N 728407 Status: New</p>

Watercourse Crossing ID	WX23
	<p>Watercourse Width: 3 m Watercourse Depth: 0.7 m Notes: Watercourse located in an incised gully which is approximately 15 m wide and 1.5 m deep.</p>
<p>Photograph Looking Upstream</p>

<p>A photograph showing a narrow watercourse flowing through a grassy gully. The water is dark and reflects the sky. The surrounding vegetation consists of tall grasses and purple heather. In the background, there are rolling hills under a clear blue sky. A thin vertical pole is visible in the center of the gully.</p>
<p>Photograph Looking Downstream</p>

<p>A photograph showing a watercourse flowing through a grassy gully, viewed from a downstream perspective. The water is dark and reflects the sky. The surrounding vegetation consists of tall grasses and purple heather. In the background, there are rolling hills under a clear sky. A thin vertical pole is visible in the center of the gully.</p>

<p>Potential Crossing Type Likely Required CAR Authorisation</p>	<p>Open span bridge or culvert Licence</p>

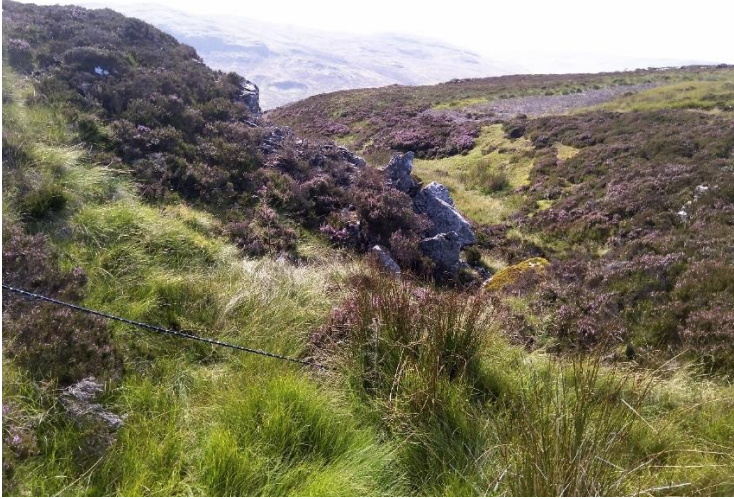
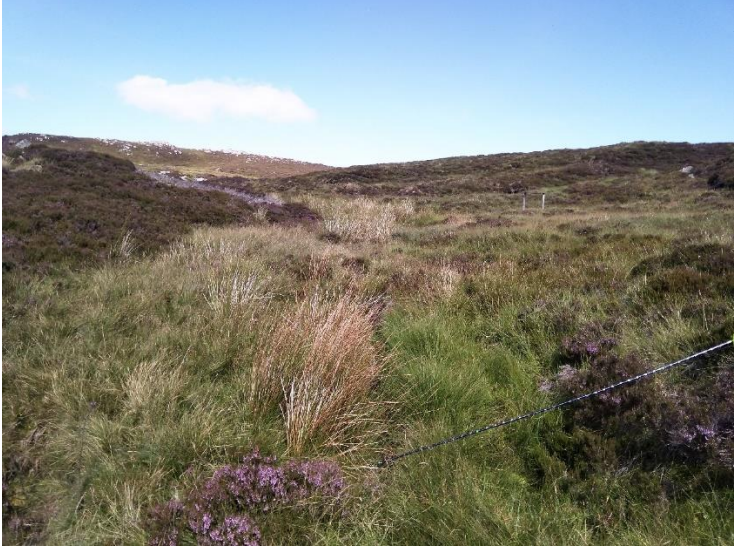
Watercourse Crossing ID	WX24
Watercourse Crossing Details	<p>Grid Reference: E 267550 / N 728068</p> <p>Status: New</p> <p>Watercourse Width: 0.5 m</p> <p>Watercourse Depth: 0.1 m</p> <p>Notes: Watercourse is located within a wider channel which is approximately 10 m wide and 3 m deep.</p>
Photograph Looking Upstream

Photograph Looking Downstream

Potential Crossing Type Likely Required CAR Authorisation	Culvert Registration
